**PHASE I ENVIRONMENTAL SITE ASSESSMENT**

**U.S. EPA BROWNFIELDS ASSESSMENT PROJECT  
SEMINOLE MILLS SITE  
CLEARWATER, SOUTH CAROLINA**

**APRIL 11, 2005**

**MACTEC PROJECT 6671-05-0323.01**

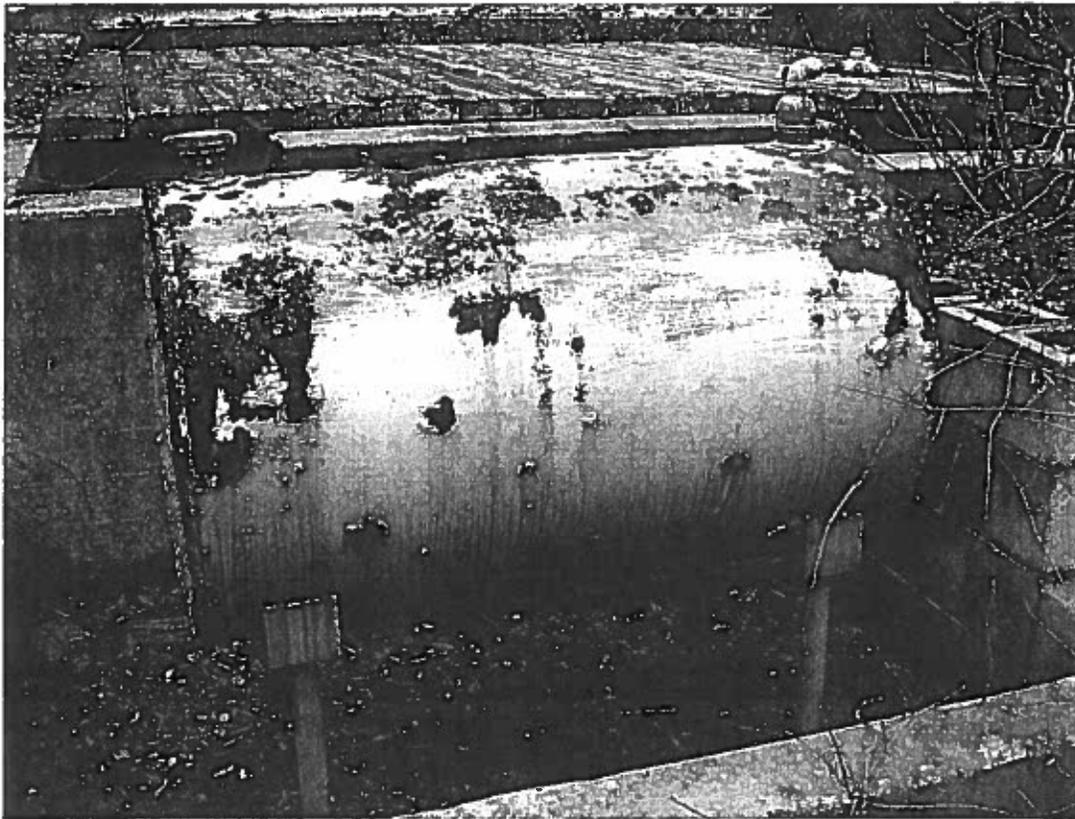
of fuel oil for the on-site boiler. A smaller, approximate 250-gallon AST was observed near the canal intake structure (Photograph 5). The 250-gallon AST was located in a concrete floored and walled containment area. This AST was likely used for the storage of fuel for the water pump observed in the pump-house. Additionally, two large ASTs reportedly used as supply and return water for the former boiler house at the site were observed east of the main building across the rear access road.

**Photograph No. 5:** Photograph of the smaller AST observed near the intake structure

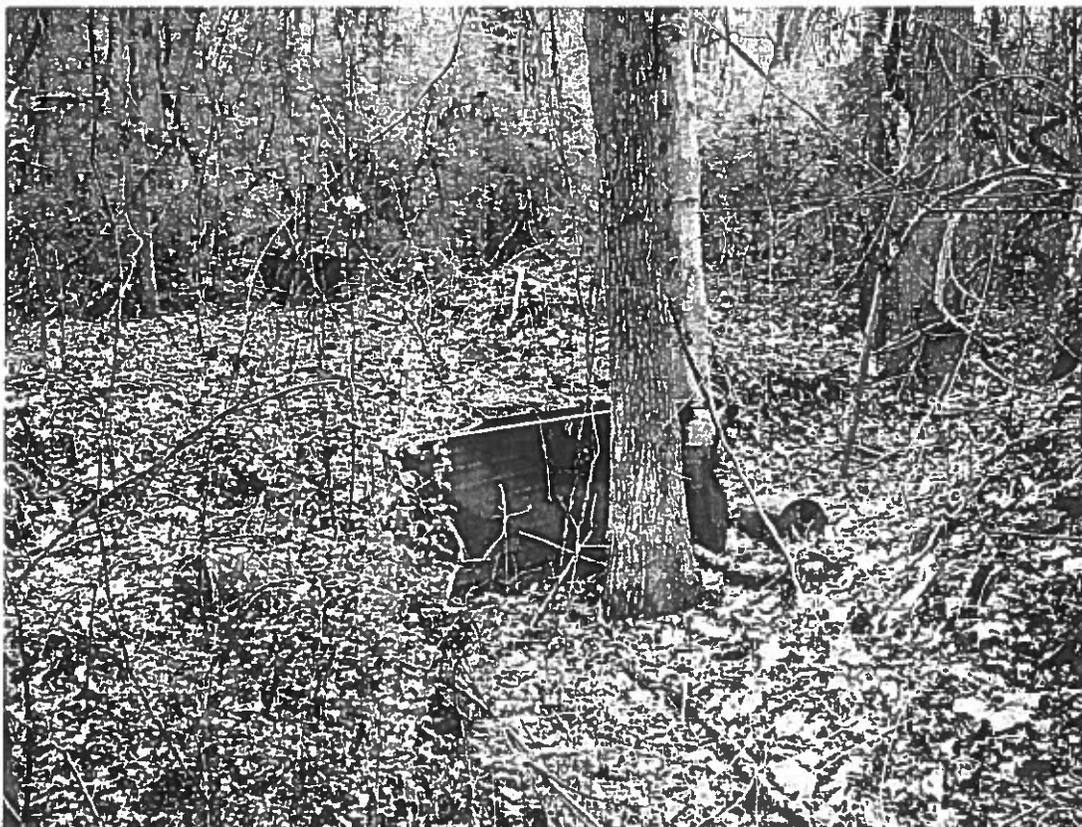
As previously mentioned, large amounts of debris remain in the interior of the building from the 1996 fire. The debris consists primarily of large mounds of bricks, concrete, structural steel, and other building materials, including asbestos-containing steam pipe and block insulation. An area of dumping was observed in the wooded area east of the main building near Little Horse Creek. The

debris in this area appeared to consist primarily of mounds of ash and several rusted 55 and 5-gallon drums (Photograph 6).

**Photograph No. 6:** View of the debris piles located in the wooded area in the eastern part of the site

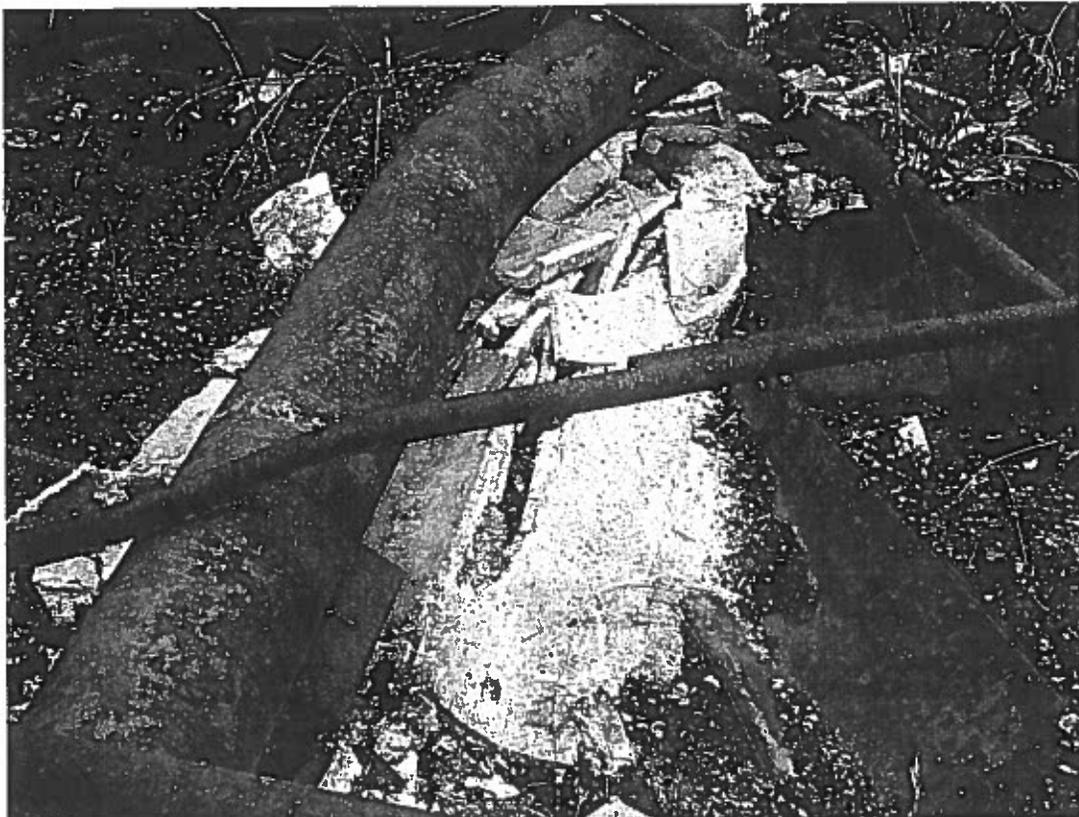
Steam pipe insulation, block insulation and roofing materials were observed scattered about the building area (Photograph 7). An asbestos survey conducted by Davis and Floyd, Inc. in 1996 identified the insulation and roofing materials around the boiler house to be asbestos-containing materials (ACM). Much of the ACM appeared to be damaged and friable. In 1996, the SCDHEC Bureau of Air Quality Control reviewed the data gathered by Davis and Floyd, Inc., and required that asbestos abatement activities be performed prior to the reclamation of any of the building materials on site. A hydraulically-operated air compressor was observed in a room near the rear loading dock. There was no other hydraulically-operated equipment observed on the site.

**Photograph No. 7:** Photograph of some of the asbestos-containing steam pipe insulation observed throughout the building area.

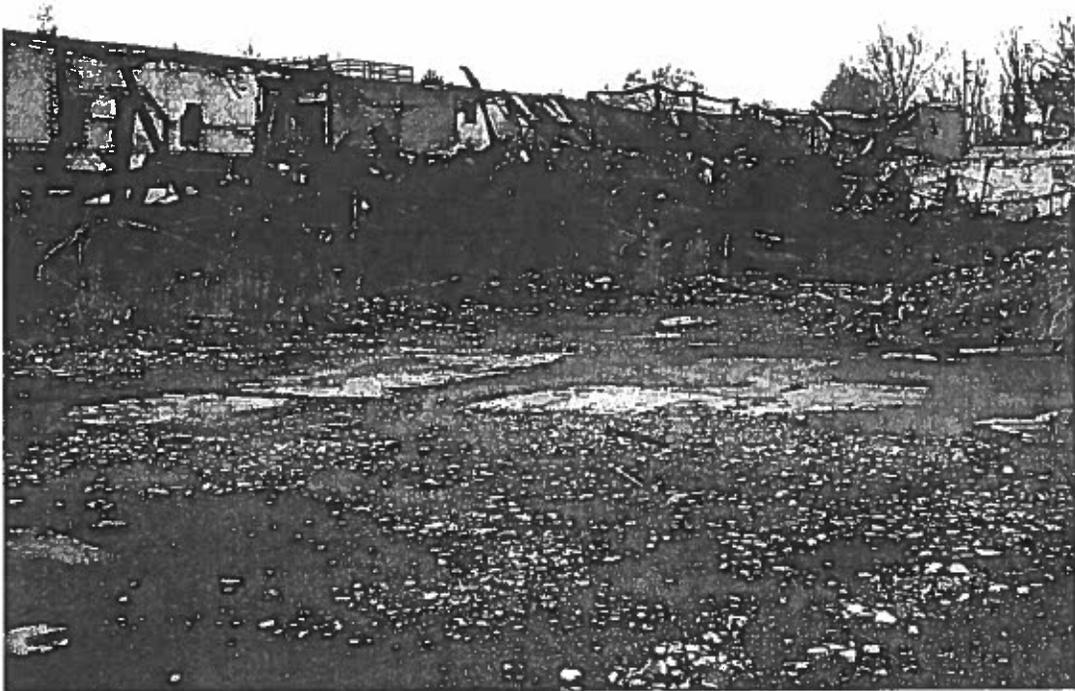
**Photograph No. 1:** View of the interior of the former mill building

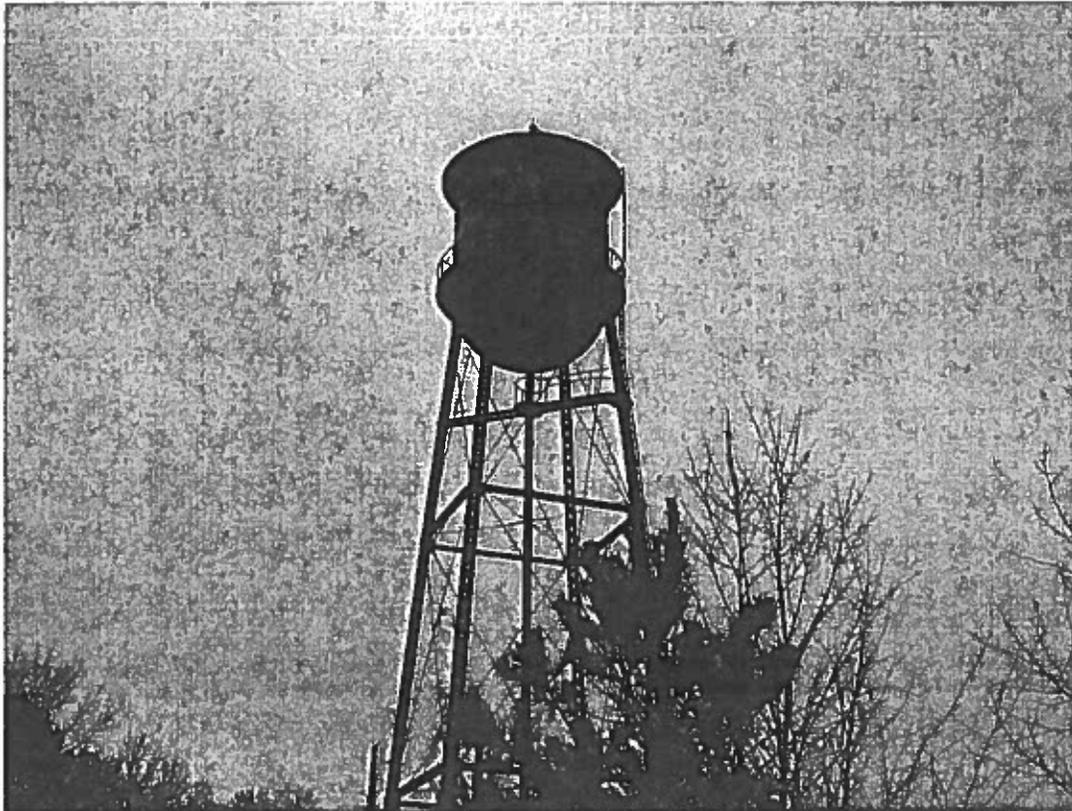
**Photograph No. 3:** Photograph of the elevated water tank on the eastern portion of the site

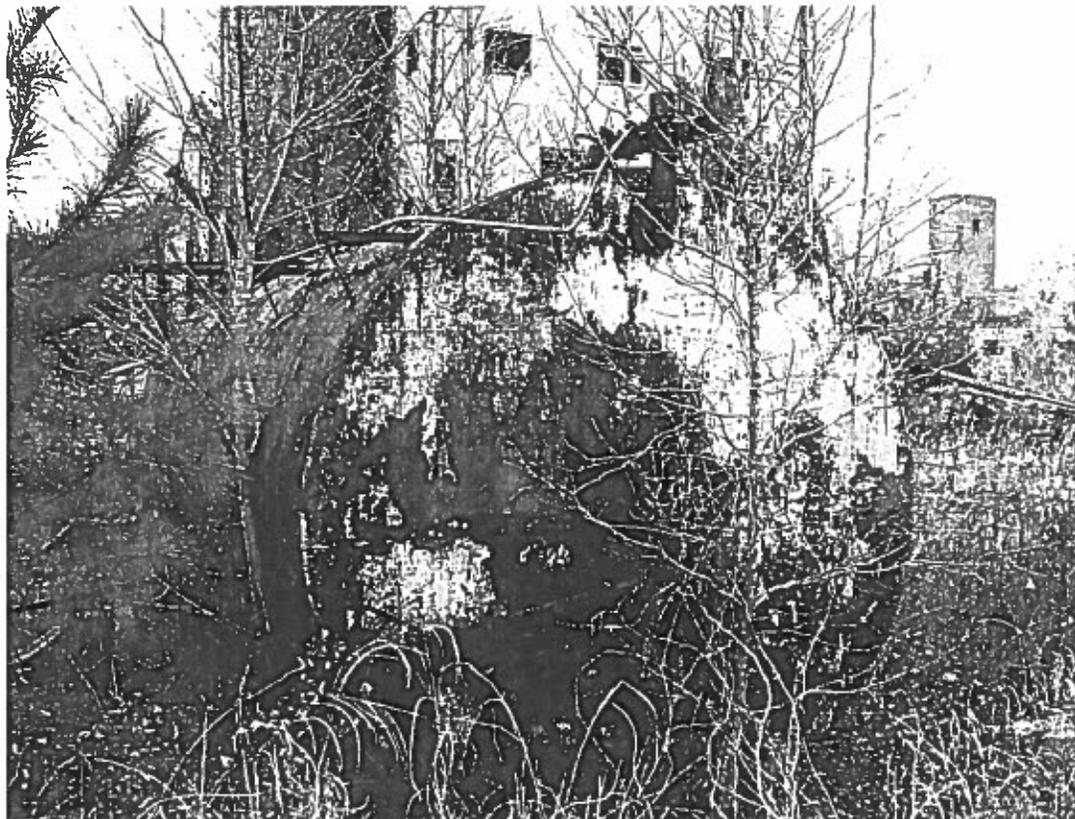
No visible indications of existing underground storage tanks (USTs) were observed at the site. MACTEC observed a large aboveground storage tank (AST) in the eastern portion of the site near the maintenance shed (Photograph 4). The AST was located in a concrete-walled containment area. The floor of the containment area consisted of gravel. Two other cradles that formerly held ASTs were also present in the containment area. These ASTs were likely used for the bulk storage

No obvious strong, pungent, or noxious odors were noted during the site reconnaissance, with the exception of a slight petroleum odor noted near the large bulk storage AST in the eastern portion of the site (Refer to Section 4.1.1).

**Photograph No. 4:** Photograph of the large AST located on the eastern portion of the site
